Wireless Sensor Monitoring Test Documentation for UCSD Shake Tests

Yizheng Liao, Anela Bajric
Department of Civil and Environmental Engineering
Stanford University

December 17, 2014

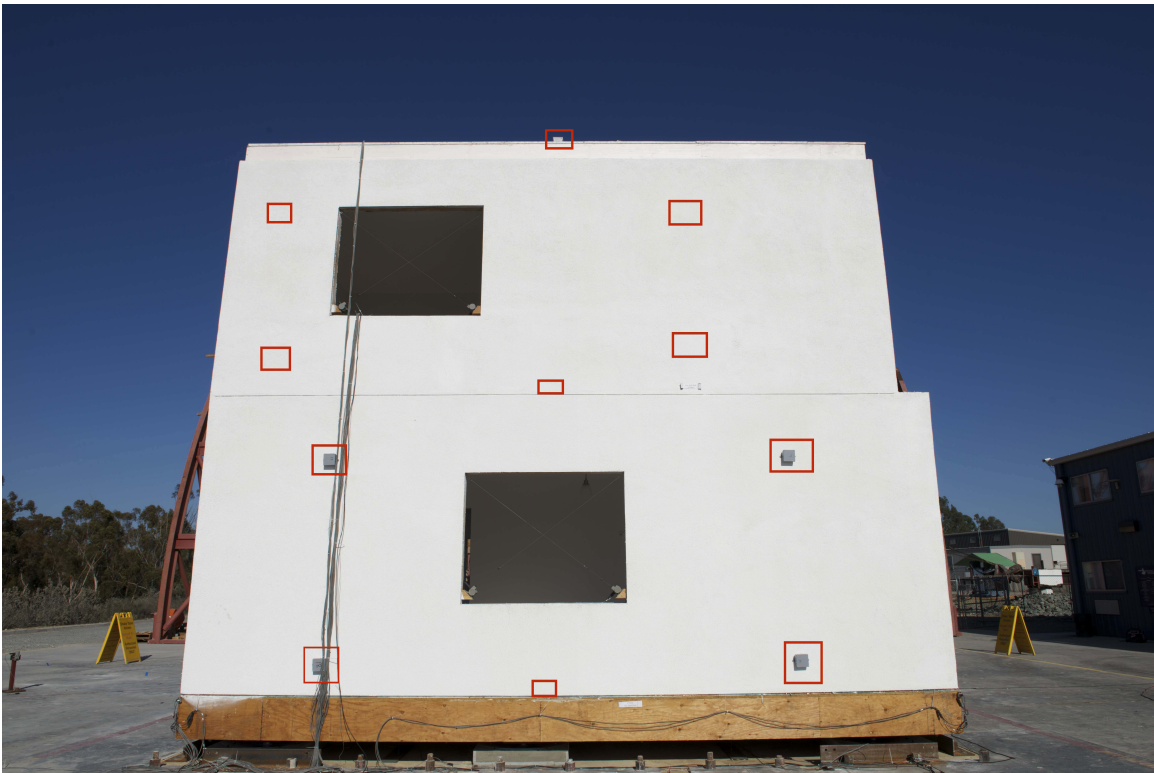
Figure 3: Sensor location on the West side wall: Exterior wall. The squares indicate the locations of the sensors

All the sensors were placed on the West or the East side of the structure since the shaking direction was West-East direction. Fig. 1, Fig. 2, Fig. 3, and Fig. 4 show the locations of the sensors on a side view drawing and in the field test. Fig. 5 and Fig. 6 indicate the distances among the sensors and the base stations.

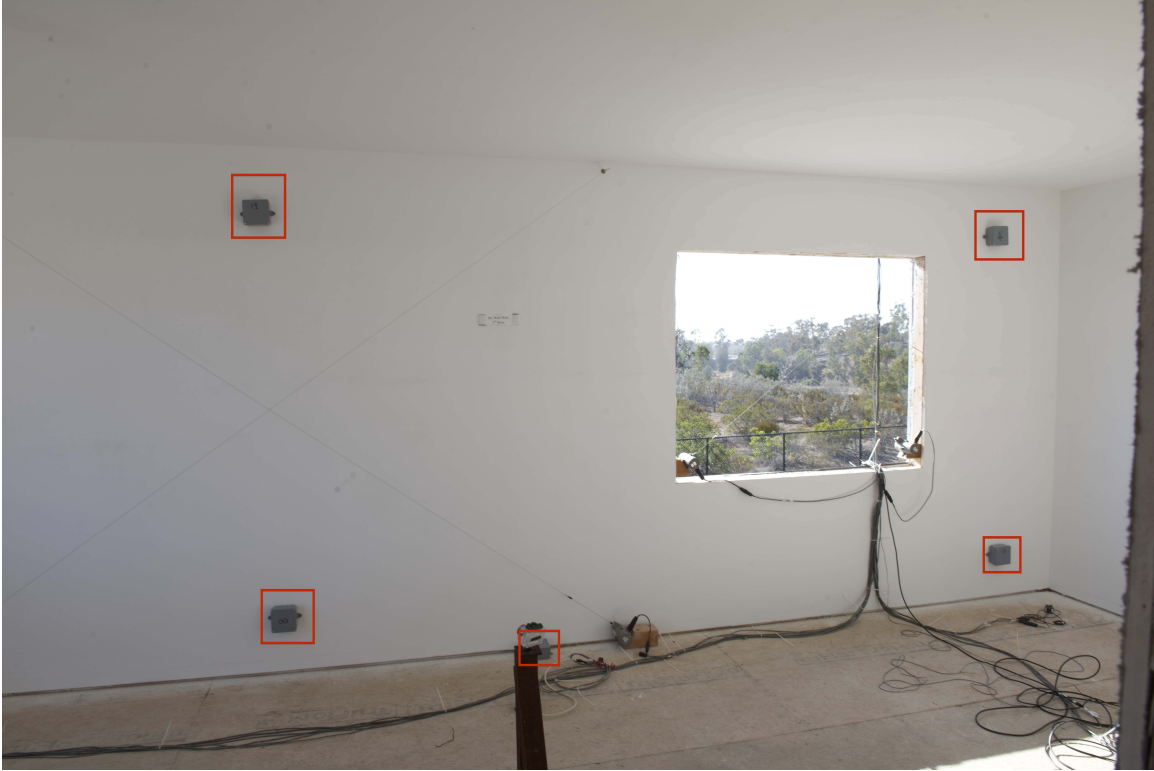
Figure 4: Sensor location on the West side wall: Interior wall of the 2nd floor. The squares indicate the locations of the sensors

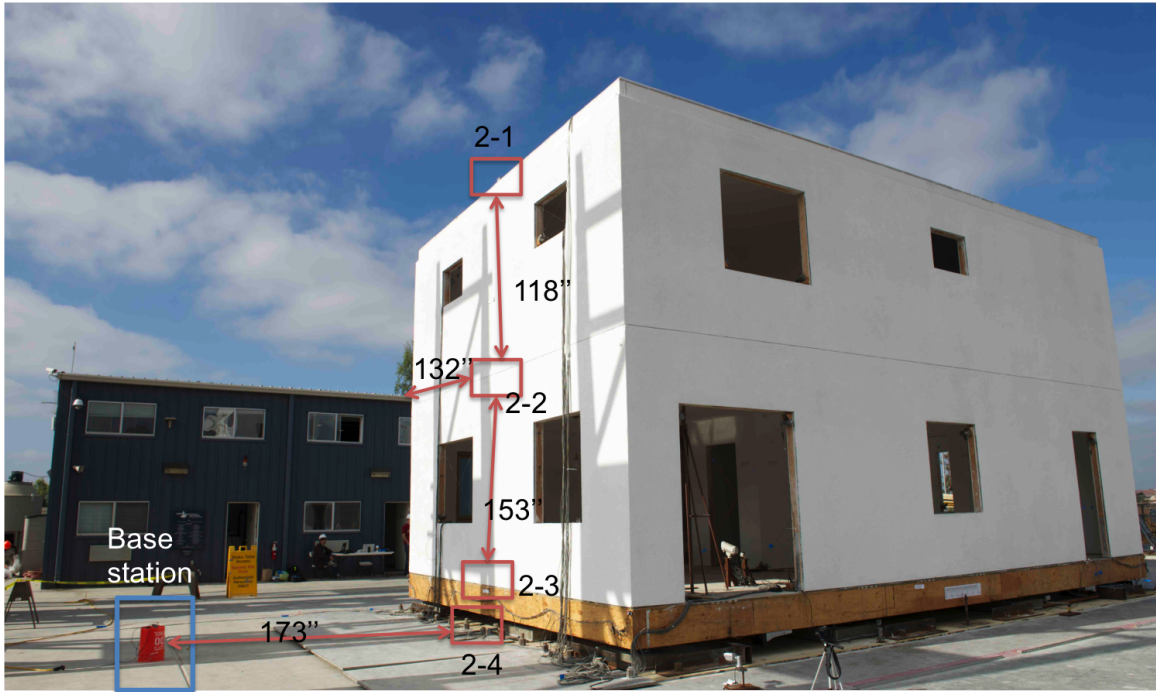
Figure 6: Sensor location on the East side wall with the distances.
